CONTRACT: INTERMOUNTAIN

THE ENCLOSED DOCUMENTS FORM A RECORD OF MEASUREMENTS TAKEN
DURING STRIPDOWN / REBUILD OF THE MACHINE IDENTIFIED ABOVE

TITLE: 2003 HP REPLANT

Name of Station INTERMOUNTAIN		Unit No: 1		S.T. No: T11246	
Title of Report HP TURBINE REPLANT			Report By W Falconer		
Summary					
<p>The unit was taken out of service on 1st March 2003 for a planned 28 day outage.</p> <p>Work included:-</p> <ul style="list-style-type: none"> • HP turbine rotor and inner shell (cylinder) replacement (upgrade) • IP turbine inspection • Steam admission valves inspection • Limited generator inspection and repair • Extensive boiler inspection and repair • Extensive boiler inspection and modification (upgrade) • Inspection and modification (upgrade) of various auxiliaries including boiler feed pump turbines and main CW cooling <p>This report describes the fitting of the new HP turbine rotor and inner shell.</p> <p>The turbine generator was resynchronised on 29th March 2003, and returned to commercial operation as scheduled.</p> <p>Formal performance tests were carried out during week commencing 7th April 2003. The results confirmed that the guaranteed efficiency had been exceeded.</p> <

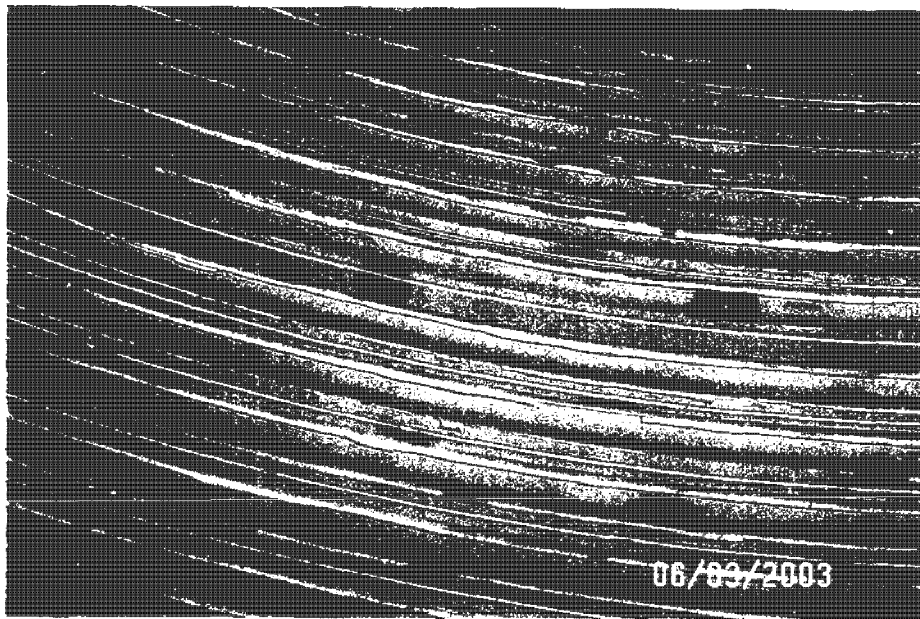
Photograph 3 - OLD INLET GLAND SHOWING HEAVY BOTTOM RUBS
